Minimum Documentation Fiche 2011

depicted item: Deutsches Hygiene-Museum (German Hygiene Museum)

1. **Identity of building/group of buildings/urban scheme/landscape/garden**
current name of building:
 - 1.1 Deutsches Hygiene-Museum (German Hygiene Museum)

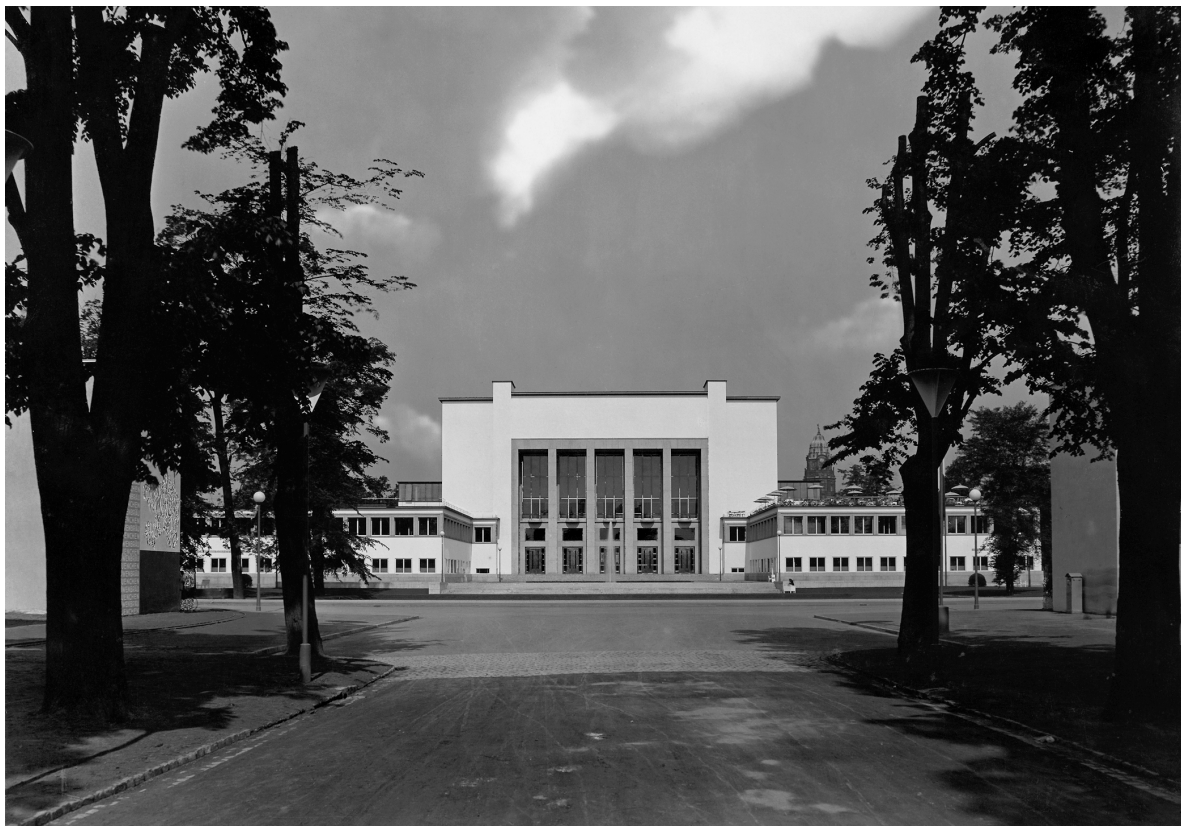
Picture 1: Main façade with entrance, 1930
source: <http://www.dhmd.de/index.php?id=1461>
Copyright Deutsches Hygiene-Museum
date: 1930

"Its monumental character comes from the cubistic central building whose facade is dominated by four pillars flanking the entrance hall and vestibule." (3)

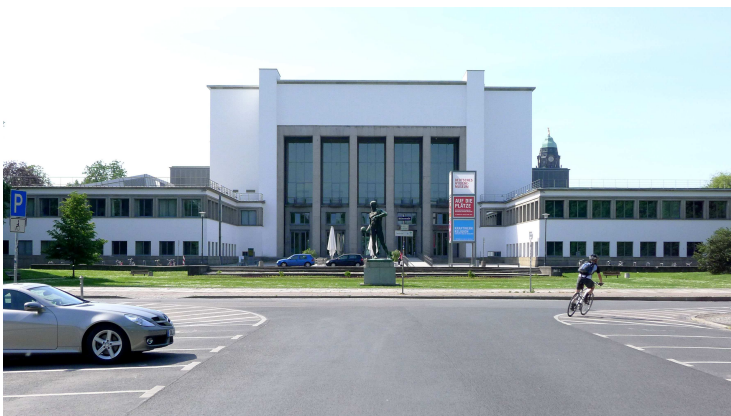
Picture 4:
 Main façade (south-east) with entrance in the central and frontal buildings to both sides.
 Diana Zitzmann, June 2011

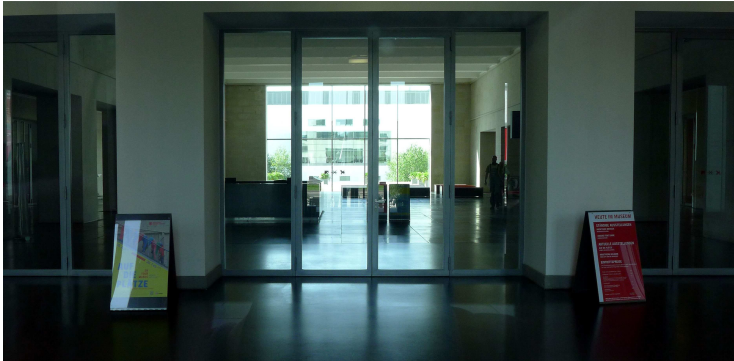
Picture 5:
Detail of main façade (south-east). After reconstruction
by Kulka & Partner with large glass window to courtyard.
Diana Zitzmann, June 2011

1998: Kulka and Partner (Köln/Dresden) receive call for reconstruction and modernization (architects involved see (6)). 1999-2011: construction works aiming at the restoration of the original design idea, accompanied by the demolition of all later additions (e.g. congress hall by Künzer). Reopening of the foyer to the court-yard, reconstruction of glass ceilings for exhibition-grounds Additions for restaurant and shop, new one-storey building for a depot in the courtyard with terrace on the top.

Originally a wall of glass existed between the entrance hall and the yard. A, for this time, novel technology (hydraulic lifting) allowed the remote controlled movement of this glass wall. ((1), S.199)

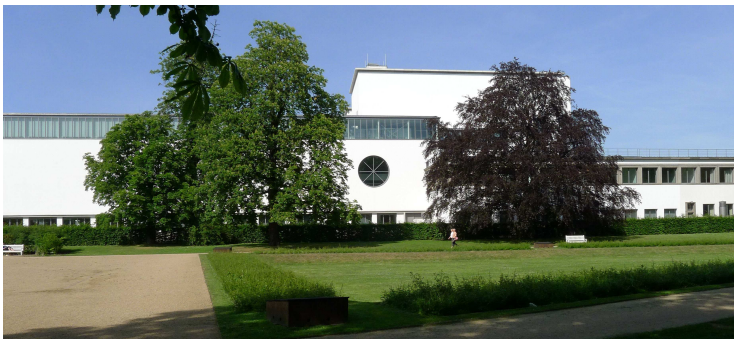
Picture 6:
Façade to the southwest. Left part: Backward part with exhibition
halls; center: Central part with staircase (round window); right:
Southern frontal building
Diana Zitzmann, June 2011

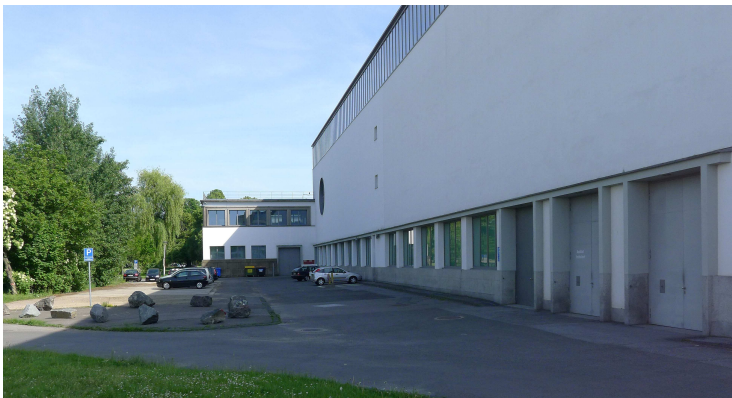
Picture 8:
Part of northeast façade with Northern frontal building.
Diana Zitzmann, June 2011

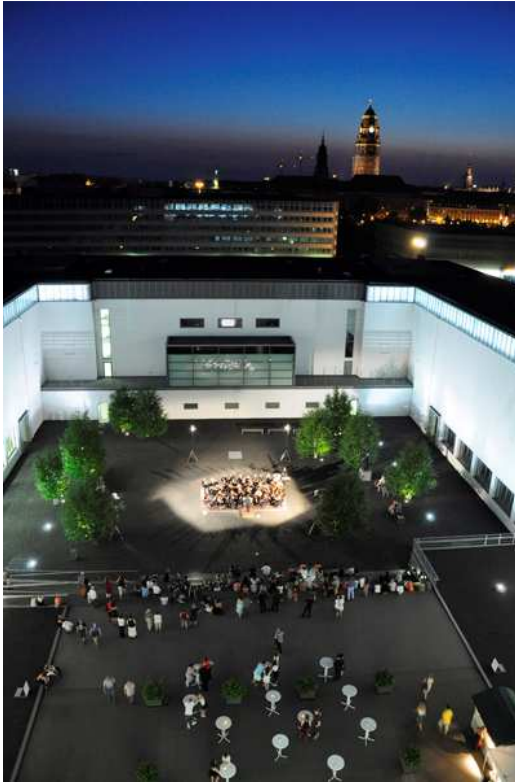
Picture 9:
 Court-yard, View from the central part to the backward wings (view to northwest). After reconstruction, around 2010.
 source: Deutsches Hygiene-Museum

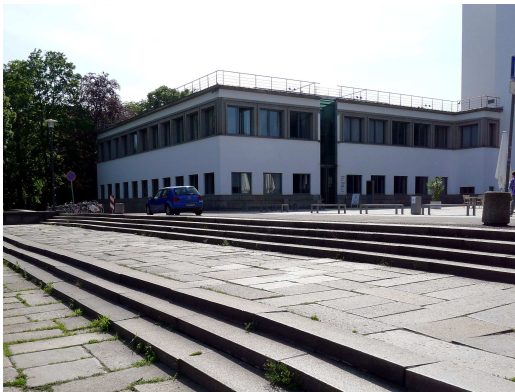
Picture 10:
 Southern frontal building with new glass gap by COOP Himmelb(lau)
 Diana Zitzmann, June 2011

1992: competition for reconstruction and modernisation, winner: COOP Himmelb(l)au (Wien). 1994: beginning of reconstruction. Construction works on Southern frontal building (office and seminar rooms); implementation of a new entrance (COOP Himmelblau) (see picture 10),
