Minimum Documentation Fiche 2003

depicted item: "Röntgenröhrenfabrik Müller" / X-ray tube factory Müller, Hamburg, (west elevation)

db code
1. Identity of building/group of buildings/urban scheme/landscape/garden	
1.1 current name of building: Philips Medizin Systeme GmbH / Philips Medical Systems (PMS, Hamburg), name of the company	3
1.2 variant or former name: "Röntgenröhrenfabrik Müller" / X-ray tube factory Müller, Hamburg	4
1.3 number & name of street: Röntgenstrasse 22-26	5
1.4 Town: Hamburg	6
1.5 Province/state: Hamburg	7
1.6 zip code: 22335	8
1.7 Country: Germany	9
1.8 national grid reference:	10
1.9 classification/typology: factory and administrative building (head office)	11
1.10 protection status & date: buildings are not individually protected, ensemble listed	12

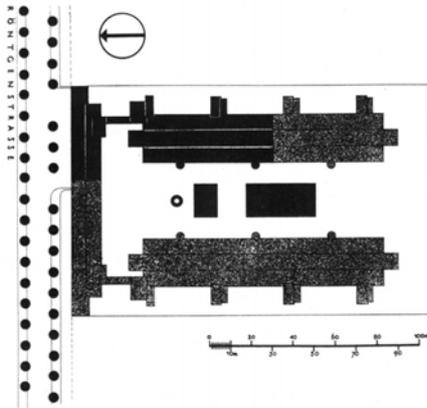
2. depicted item: historical site plan

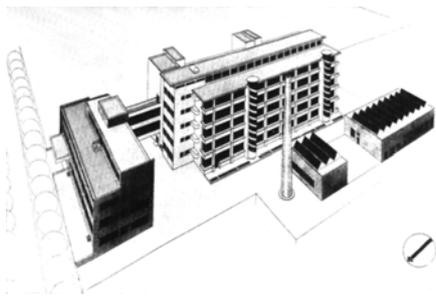
3. depicted item: perspective

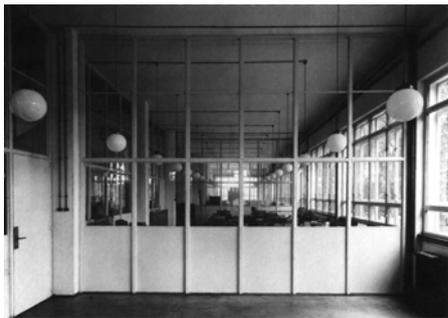
4. depicted item: interior administration with glazed partitions

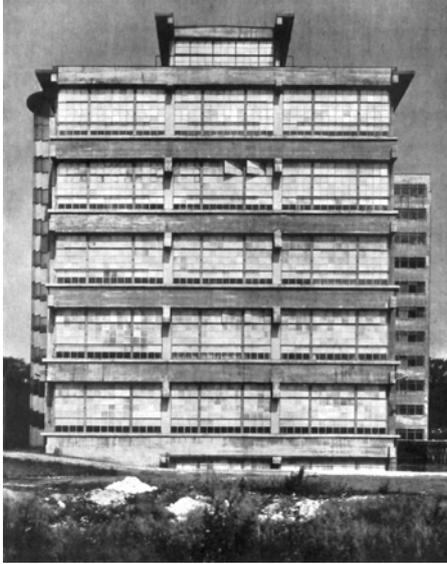
5. depicted item: elevation with possibility of annexation (south elevation)
source: Moderne Bauformen 1932, vol. 18, p. 491-499 (Ernst Scheel)
date: ca. 1930

4.1	Technical	
	The construction of the factory (upward tapering skeleton) is quite interesting and innovative, especially in connection with the hygiene requirements.	
	Another interesting point is, that a lot of factories of the Modern Movement were right from the start designed to allow later extensions of the production and office facilities. Factories that were built in the 19th and early 20th century usually had no provisions for expansions of the building. Instead, in most cases, apparently haphazard outbuildings and annexes were added. But in the example here, the architect had planned a symmetrical, U-shaped plant. Only one section of the "U" was actually built, which was constructionally intended to be extended in horizontal direction (see pictures).	23

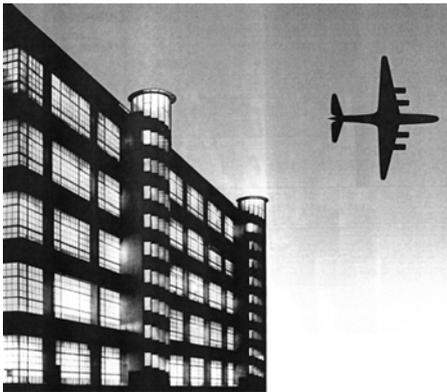
6. depicted item: west elevation with x-ray effect at night (unknown photographer)
source: Todtmann, Heinz: So sehen und wissen wir mehr (booklet), C. H. F. Müller A.G. (Hrsg.),
Hamburg s.a. [ca. 1955], PMS Archive
date: ca. 1955

4.3	Cultural & Aesthetic	
	The X-ray tube factory is an interesting example for the integration of the building in the corporate identity concept of the company. For instance the building is used for the letterhead; therefore the existing buildings were altered in order to obtain a better visual effect. Here we can notice a clear difference to the 19th-century representations, where the plants were shown from the bird's perspective and the pictures were often very true to detail. The use of the factory building in the marketing concept, partially sharpened to a point, may be interpreted as an identification of the enterprises with the Modern Movement, even if just for advertising reasons, following the spirit of innovation as a corporate image.	25
	The X-ray tube factory became a landmark when seen from the air and approached from the Hamburg-Fuhlsbüttel airport, particularly because of its impressing skeleton effect in the dark, which plays intentionally with the theme of x-ray photographs.

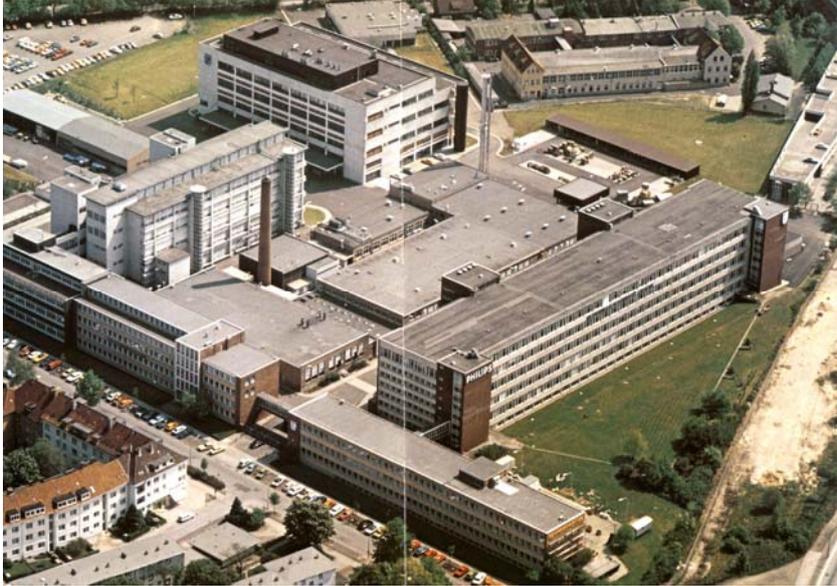
7. depicted item: arial view of the extensions of the company Philips in Hamburg, at the left
"Röntgenröhrenfabrik Müller" by Karl Schneider
source: Fehr, Werner: C. H. F. Müller ...mit Röntgen begann die Zukunft. Überliefertes und
Erlebtes, Hamburg 1981, (unknown photographer)
date: ca. 1980

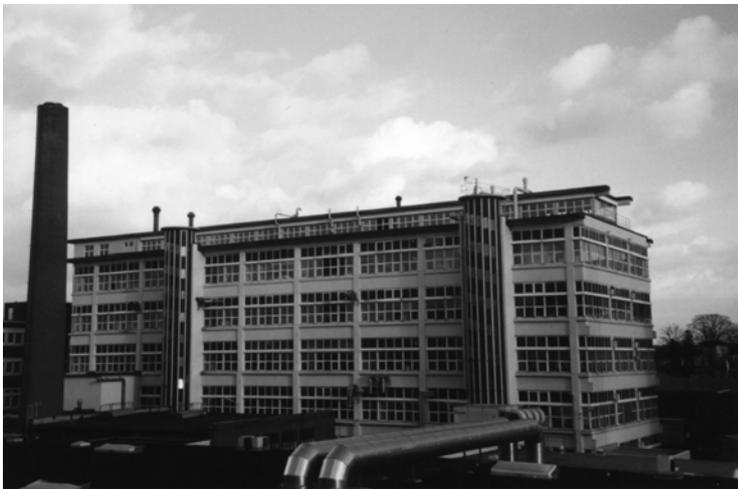
8. depicted item: current condition (west elevation)
source: Ingrid Ostermann
date: 12/2001

2.6	current use: still in use for administration, production and workshop of Philips (PMS)	18
2.7	current condition: good condition (facades need some repair work due to cracks below the sills)	19
